Impact and Post Impact Behavior of Hybrid Composites

In this study, the effect of low velocity impact response of Kevlar/carbon hybrid composite has been investigated. Then the impacted specimens were subjected to compression and buckling tests at room temperature experimentally. The height, width and thickness of the specimens are 150, 100 and 2.1 mm, respectively. Impact tests have been performed under different impact energy levels by using low velocity impact testing machine. Compression and buckling tests were conducted by Shimadzu testing machine. According to obtained results, the damage increases by increasing the impact energy level in the subjected specimens to impact test. Compression strength value is higher about 3 times than buckling strength value.

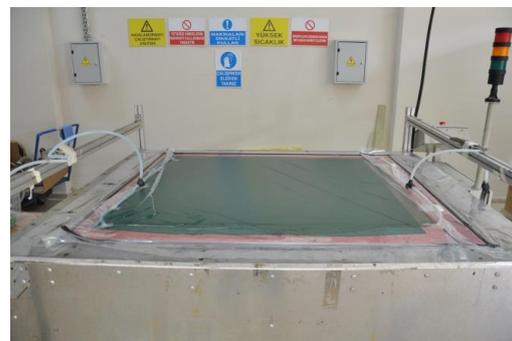
Figure 1: Vacuum Assisted Resin Infusion Molding Process

Woven kevlar and carbon fibers were used as rein forcing material to manufacture laminated composite plates. Laminating Resin MGS L160 and a Hardener MGS H160 have been chosen as a matrix material with ratio of 4:1 of the resin and hardener. Prepared specimens of laminated composite plates carried out by using Vacuum assisted resin infusion molding (VARIM) technique at 80 °C for 8 hours as shown in Figure 1, then the temperature decreased progressively to room's temperature. Eight laminas were located in manufacturing process; a wet cutting machine was used to produce specimens. Figure 2 shows prepared specimens of composite with dimensions of height, width and thickness as 150, 100 and 2.1 mm, respectively.

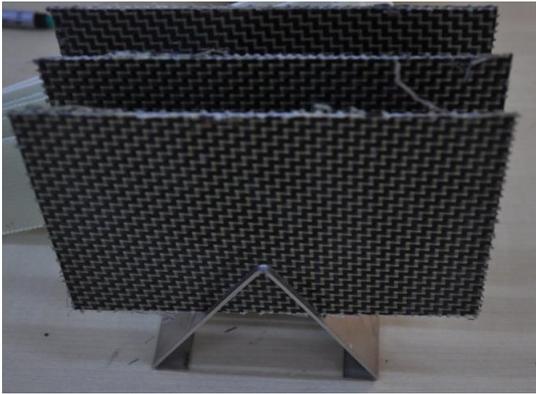
Figure 2: Prepared Specimens of Hybrid Composite

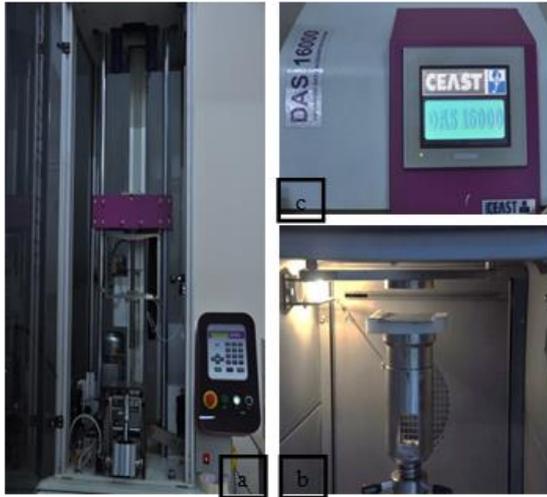
Figure 3: Impact testing machine (a) turret (b) chamber of test (c) advanced data acquisition system

Prepared specimens of laminated composite plates were subjected to low velocity impact (LVI) by using the Fractovis Plus impact testing machine as shown in Figure 3. The diameter of impactor nose was 12.7 mm hemispherical which was connected with force transducer which has maximum loading up to 22.4 KN, as well as the velocity and maximum energy for impact testing machine is 24 m/s and 1800 J, respectively. The total impact mass is 5.02 kg containing force transducer, impactor nose and crosshead.

Different impact energy values (5, 7.5, 10, 12.5 and 15) J were chosen, in the experimental investigation and every test was repeated eight times for each energy level applied. The prepared specimens were based on inner diameter with 76.2 mm of the clamping apparatus before the impact test. The impact points was located in the center of the samples because the prepared specimens were mounted on the fixture at base of the impact machine as shown in the Figure 3-b, and during the impact tests all the data were obtained by using the advanced data acquisition system (DAS) which can give 16000 data for each test Figure 3-c. Time, force, velocity, displacement and absorbed energy were determined as results from the software of data acquisition system which based on the Newton's second law and kinematic equations.

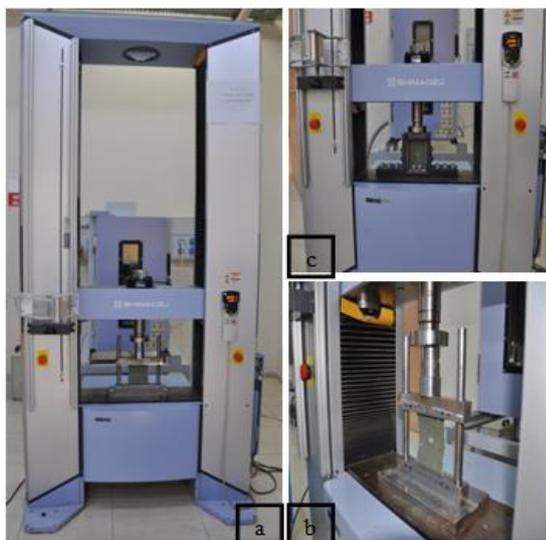
Figure 4: (a) The Shimadzu test machine (b) apparatus of buckling test (c) apparatus of compression test

The dimensions of specimens were Prepared according to ASTM D 7137 with 150 mm, 100 mm height and width respectively, specimens of laminated composite plates were subjected to compression and buckling tests after impact test in order to study effect impact loading on the compression and buckling strength of the samples experimentally. The compression and buckling tests have been carried out at room temperature by using the Shimadzu AG with 50 kN test machine as seen in Figure 4-a. In the buckling test, apparatus was used with two clamped ledges and two free ledges as the boundary conditions as observed in Figure 4-b. However, there aren't free ledges in the apparatus of the compression test as shown in Figure 4-c. The material strength depends on the strain value. In other word, material strength raises by increasing strain value. The results have been obtained as a text file on the data card from the test machine. Then, curves of stress-strain are obtained for each sample. The buckling and compression after impact stresses are calculated by,

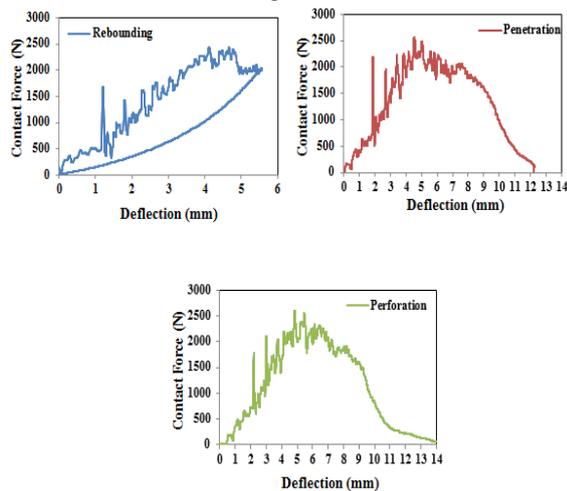
Figure 5: The typical contact force-deflection curves

The woven Kevlar/carbon composite was subjected to single impact loading at room temperature. The curves of contact force with deflection represent damage processes which consist of three modes as can be seen in the Figure 5. Firstly rebounding case occurs at return of the impactor after impact the top surface of specimen; secondly penetration case happens when the impactor impact the sample without rebound which is affected by fiber and matrix type, thirdly upward motion of the impactor after impact and happening failure in the sample this damage process is called perforation case which occurs after increasing the impact energy levels. On the other hand the rebounding threshold becomes penetration and perforation threshold, respectively.

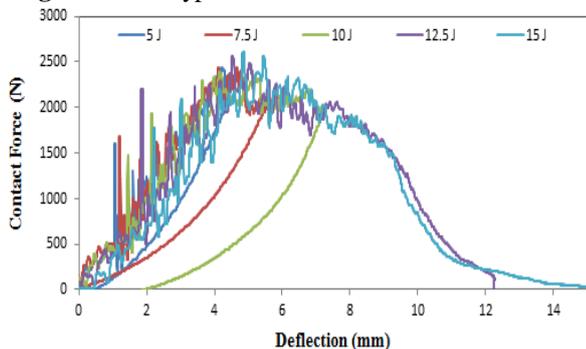
Figure 6: Contact force-deflection curves of woven composite laminated

Contact force versus deflection curves are mountain-like shaped for specimens of woven Kevlar/carbon composite laminated, all the specimens were subjected to impact test by using different impact energy value 5J, 7.5J, 10J, 12.5J and 15J. The absorbed energy and deflection increase by increasing the impact energy as can be seen in the Figure 6, the absorbed energy can be determine from the closed area of the contact force-deflection curve during the impact test. The closed curve consist of impact bending stiffness and slopes of rebounding threshold which indicate the return of impactor after impact the top surface of specimen, It is meaning that the damage occurs as a delamination and matrix cracks by using 5J, 7.5J and 10J, however the penetration case happened at 12.5J when the contact force value becomes zero in the end of the descending section. The perforation case is occurred by increasing the applied impact energy to 15J. As can be seen in the Figure 6 the impact bending stiffness of curve decreases because fully perforation of the sample. The damage also has been increased as delamination, matrix cracks and fiber breakage in the specimens of woven Kevlar/carbon composite laminated.

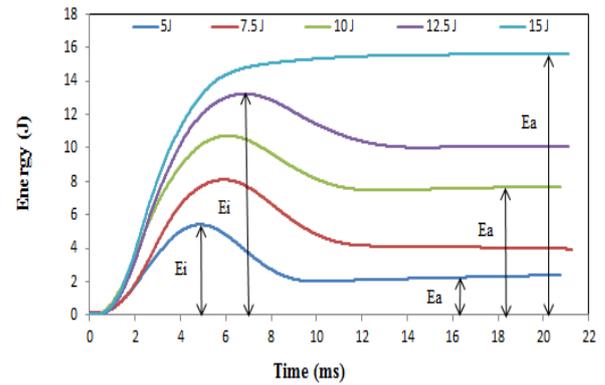
Figure 7: Energy-Time curves of woven composite laminated

Figure 7 explains energy and time response for samples of hybrid composite laminated which were subjected to different impact energy (E_i) from 5J to 15J. The absorbed energy (E_a) rises with increasing the applied impact energy despite of dissipate energy which occurs because the friction between the striker and specimen. Also it is clear that the complete perforation case is occurred after using 15 J.

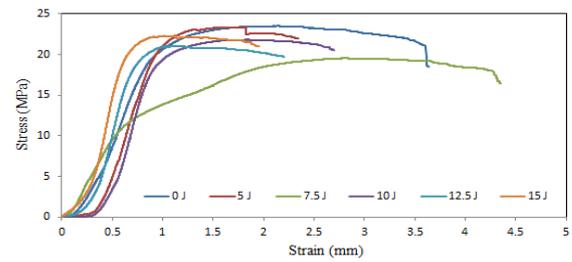
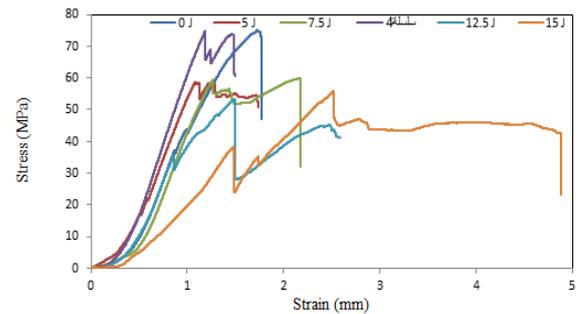
Figure 8: Stress-Strain curves of (a) buckling test and (b) compression test

Three of specimens were tested in the buckling test using apparatus with two clamped ledges, while compression test carried out on five specimens using apparatus with four clamped ledges after impact loading. In the tests, all specimens were loaded uniaxially until the failure was occurred, the results showed that compression after impact strength is higher about 3 times than buckling after impact strength of the tested samples, because buckling test apparatus has two free ledges as the boundary conditions so the fibers of Kevlar and Carbon have elasticity as shown in the Figures 8 & 9.

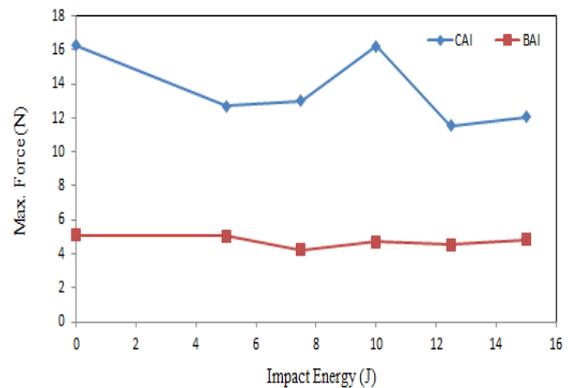
Figure 9: Max. Force-Impact Energy curves of compression and buckling after impact tests

- The buckling strength after impact is lower than compression strength after impact because two free ledges in the buckling test.
- It is clear from the Figure 9 the max. Force in compression and buckling tests occurs at 0J which means that the compression and buckling tests affected by impact loading test.
- The damage happens close to the impact point of the samples for both compression and buckling after impact test which means that low velocity impact effects on the fibers of Kevlar/Carbon hybrid composite laminated.

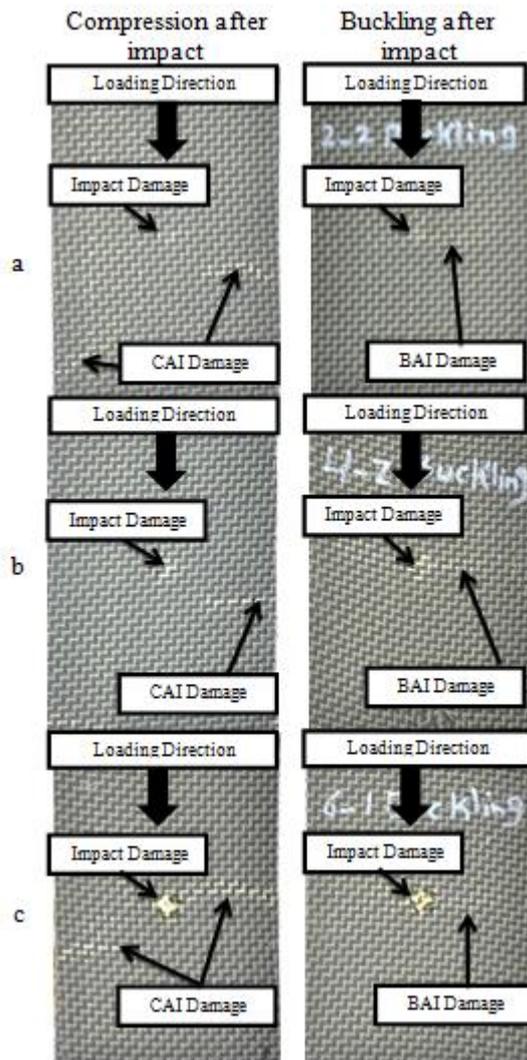
Figure 10: Damage Modes of Hybrid Composite Laminated Impacted at (a) 5J (b) 10J (c) 15J

The progressing of damage represents the change between incipient damage which occurs at low applied load values and complete failure in the sample of composite which is occurred at increasing applied load values. As can be seen from the Figure 10 impacted face at 5, 10 and 15 J, the damage like delamination in specimens are subjected to compression

after impact test is much more than the damage in specimens subjected to buckling after impact test because researcher used anti-buckling blocks in order to prevent buckling in the samples under compressive test while the apparatus in the buckling test has two free edges. The damage effects by the stacking sequence, material and laminate thickness, so the extension of damage occurs according to the interlacing architecture fibers of Kevlar and Carbon as shown in the Figure 10, and according to Aktas et al [16] the damage happens close to the impact point of the specimens for both compression and buckling tests.

Fracture force of fibers is occurred because the high bending stresses which occurs in the back face of samples. The damage modes occur as delamination, matrix cracking and fiber breakage in the impact test however in the compression and buckling after impact test the damage occurs as delamination, fiber splitting and matrix cracking.
